Inspection Report

Property Address:
123 New Street
Anytown ON A1B 2C3

The Home Inspector Inc.

Date: 2022-09-12	Time: 9:00	Report ID: THI-INC
Property: 123 New Street Anytown ON A1B 2C3	Customer: Atticus Flood	Real Estate Professional: Tracy Eskanjani Your Agent Info

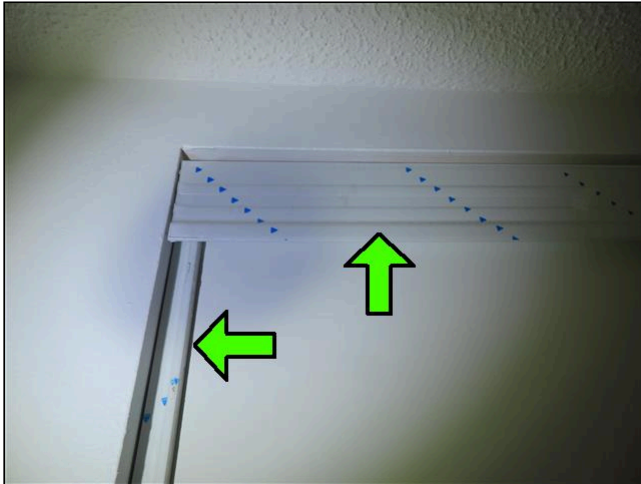
Remove protective film.

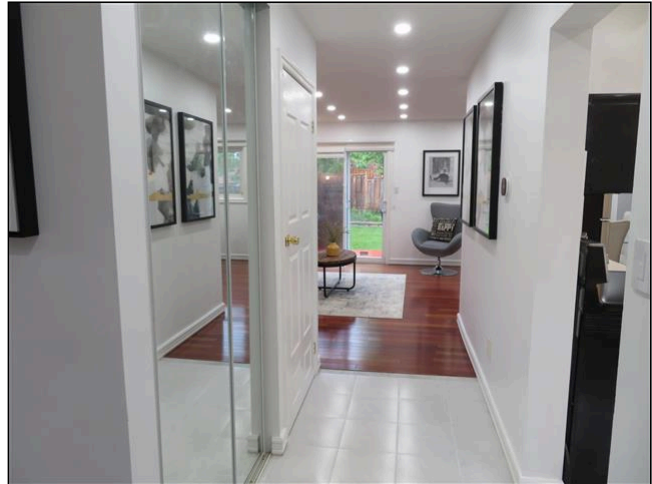
Upside down door.

1.6 Laundry closet door is upside down.

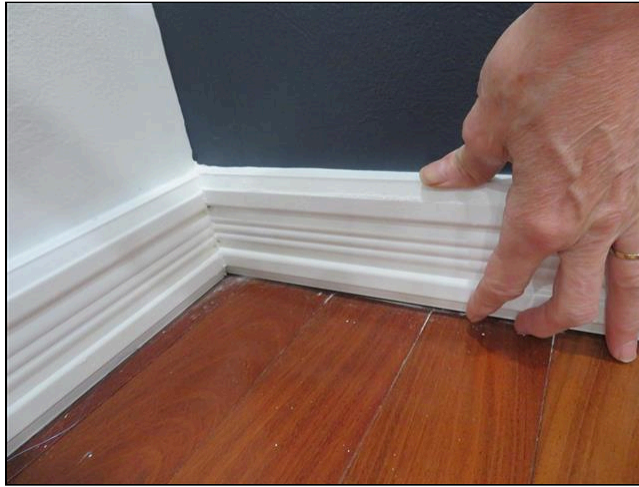
1.2 (1) Baseboard materials used are door trim. Evidence of inexperienced tradesmen. Upstairs nails to fill and top edges to caulk.

1.2 Item 1(Picture) Door trim.

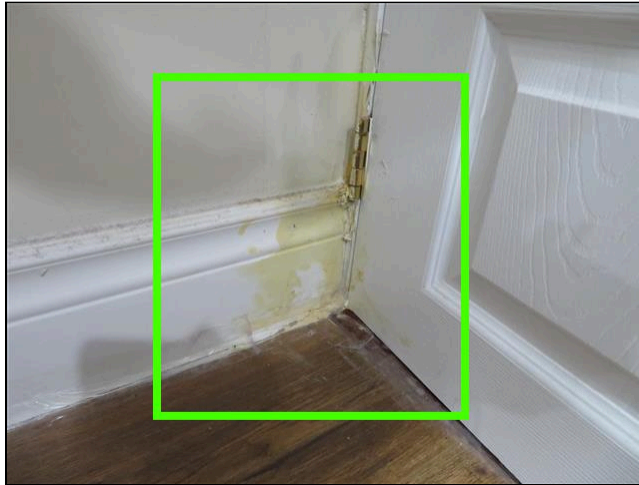
1.2 (2) There is stained trim behind the NW basement room entrance door.

1.2 Item 2(Picture) Staining. Unknown cause.

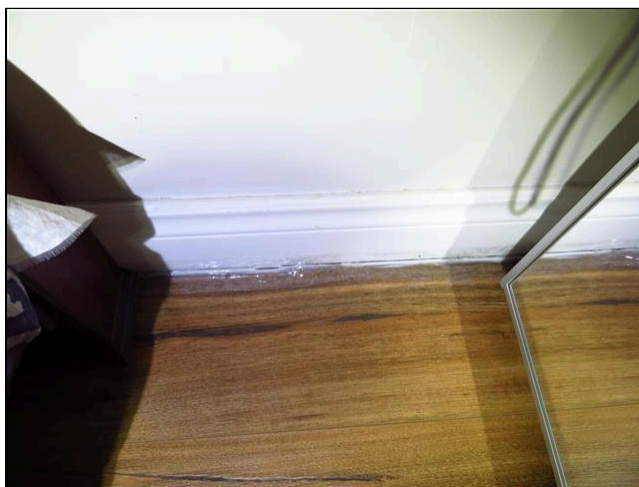
1.3 Item 1(Picture)

1.3 Basement: Tenant has taped the edges of the floor. The reason for this cannot be known. It may have been for comfort as there is plastic in the basement window as well.

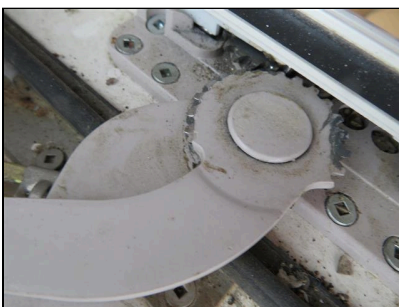
1.7 (1) The front bedroom casement windows have missing and broken hardware. New cranks are required.

1.7 Item 1(Picture) Stripped gears.

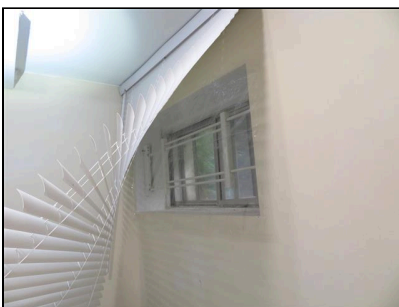
I will note, for this inspection, that the west basement window is not adequate for emergency escape. (The east window has been upgraded.) Perhaps consider this a one-bedroom with den or investigate upgrade options.

1.7 Item 2(Picture) Unsafe window.

1.7 (2) There are fire safety companies that specialize in coaching and advising regarding the upgrades required to get a retrofit certificate.

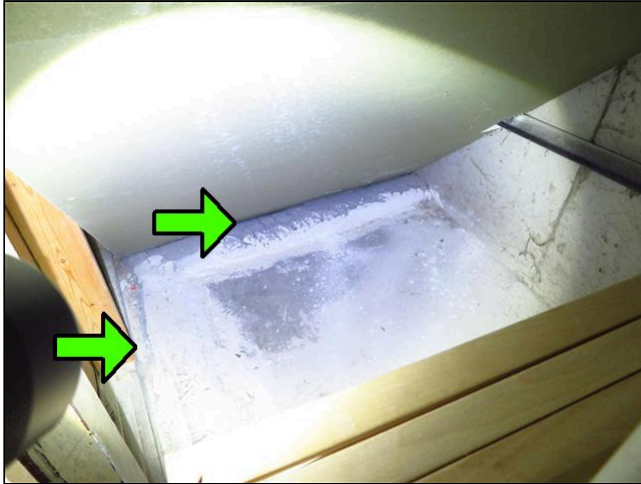
2.0 Below the basement stairs there is laundry, a water heater, furnace/ac, and a floor drain. A spill containment has been added here. Perhaps preventatively but possibly as a reaction to water spills or entry.

2.0 Item 1(Picture) Spill control.

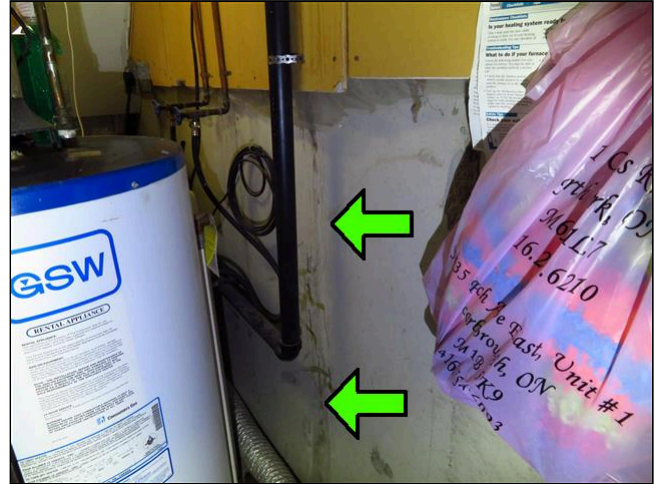
The crack in the foundation here does not appear to be a chronic water entry point. Epoxy resin repair for approximately \$500 can ensure no water entry, however, water leaks would be inconvenient but not damaging.

2.0 Item 2(Picture) Settlement crack.

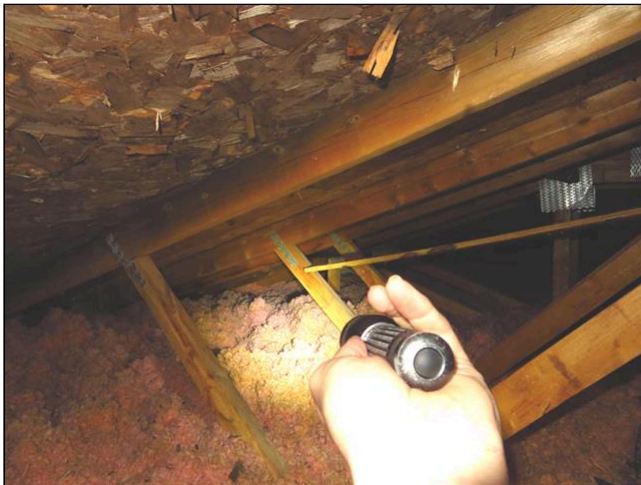
2.5 Item 1(Picture) Limited viewing.

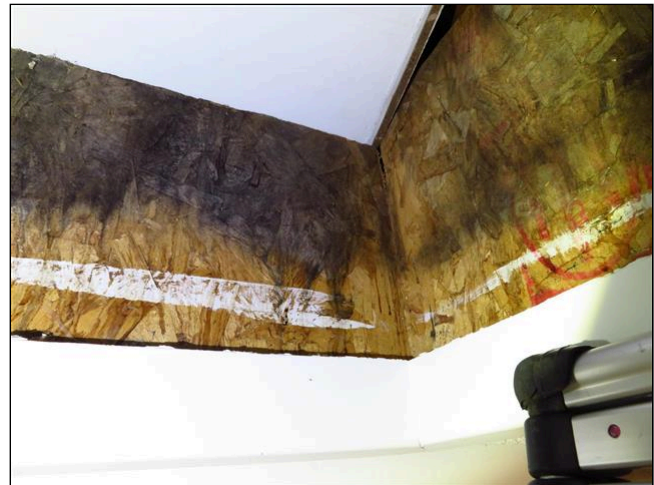
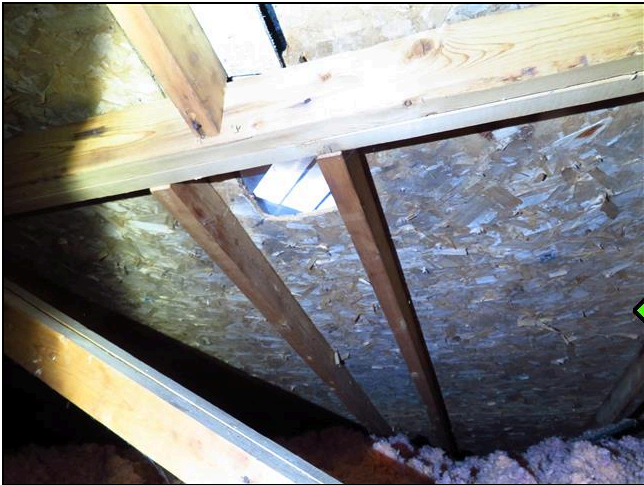
2.5 There was staining on the attic access and the roof sheathing. This is exterior and not an Indoor Air Quality hazard. This staining is related to accumulation of moisture generated by the occupants. Discharging the washroom exhausts is important. Sealing the attic floor prior to upgrading the insulation will also ensure that this staining does not become worse.

There is an additional attic vent installed to dissipate moisture more effectively.

2.5 Item 2(Picture) Staining.

2.5 Item 3(Picture) Staining

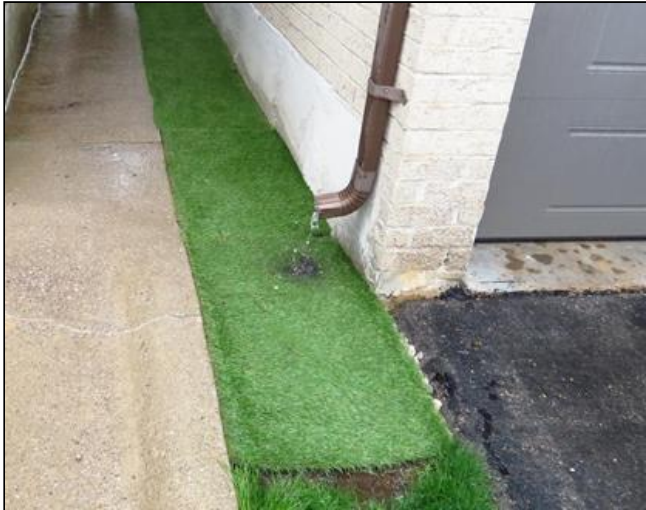
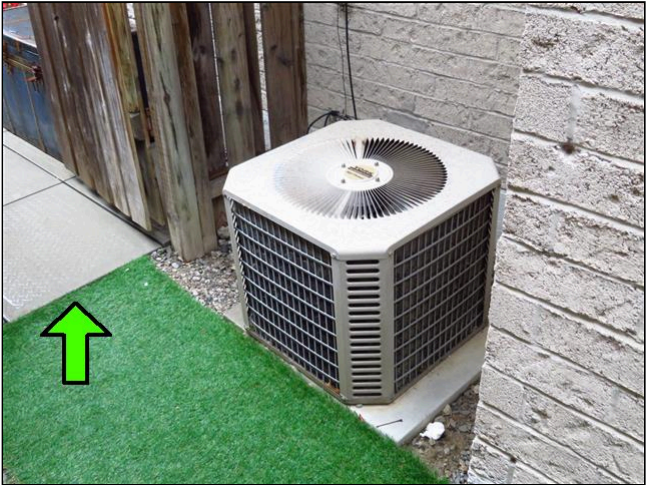
3.3 The walkway to the separate basement entrance is astroturf. This is not a suitable material for snow clearance and safety. The space is too small to accommodate flag stones and so interlock or poured concrete would be required.

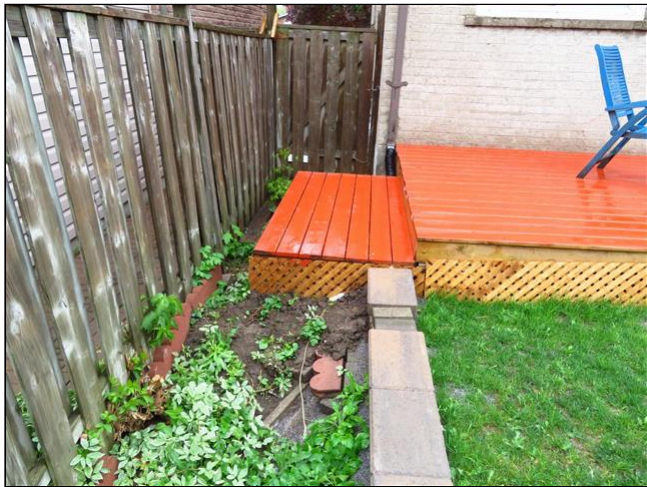
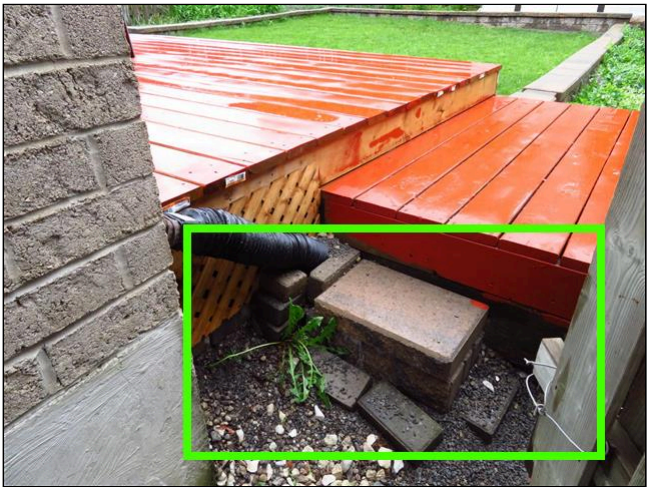
3.4 There is a step up to the deck on the east side that may be a fall hazard. Divide the rise into two equal heights. I recommend that a railing or grab bar be installed here as well.

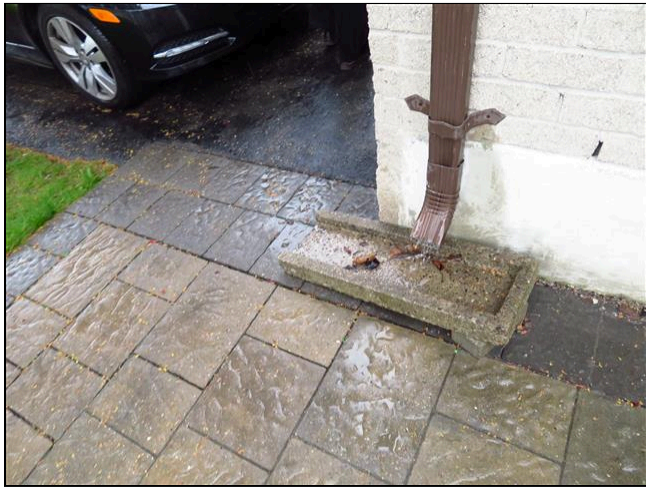
Monitor for ice.

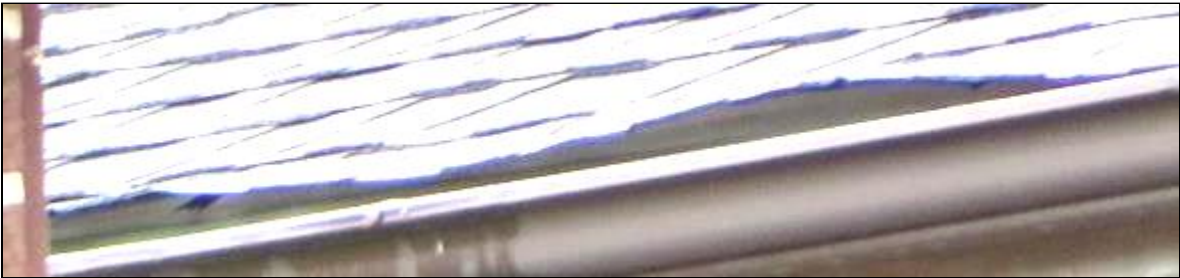
It was noted that there are two edges that are lifted. We are unable to access this area. There are no adverse affects noted in the attic or dwelling spaces. Have this investigated, and corrected if necessary, when the metal chimney is removed.

4.0 Item 1(Picture) West roof.

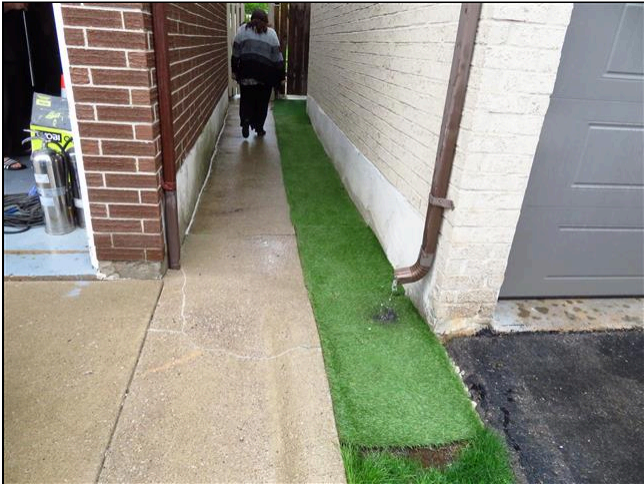
4.3 Note that the downspout on the garage will create a slip hazard when discharging water on the walkway. Ensure occupants are aware and keep the area clean and salted as needed.

4.3 Item 1(Picture) Slip hazard.

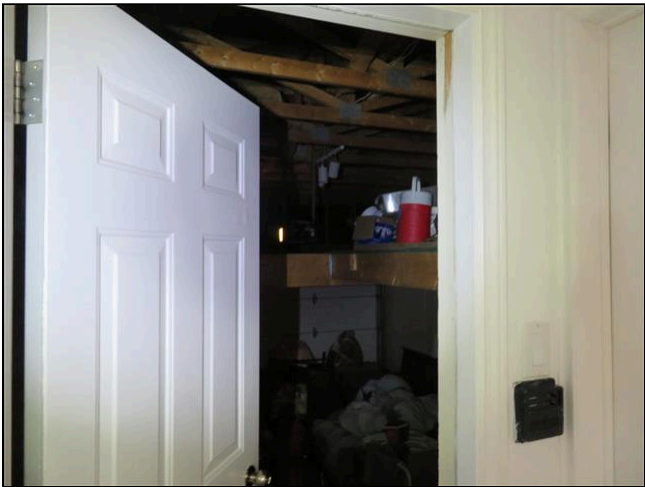
5.3 Item 1(Picture)

5.3 Requires an automatic closing device to protect from fire and toxic gases.

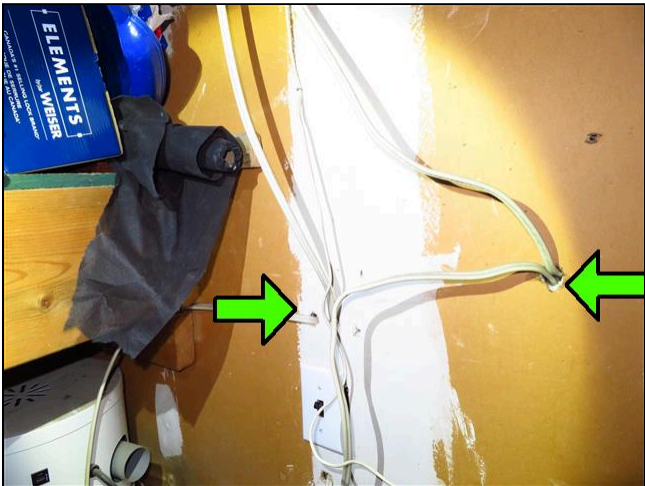
5.4 There are holes where electrical wiring penetrates the drywall. Repair/upgrade wiring as required by ESA and seal the wall where needed.

5.4 Item 1(Picture) Seal all penetrations.

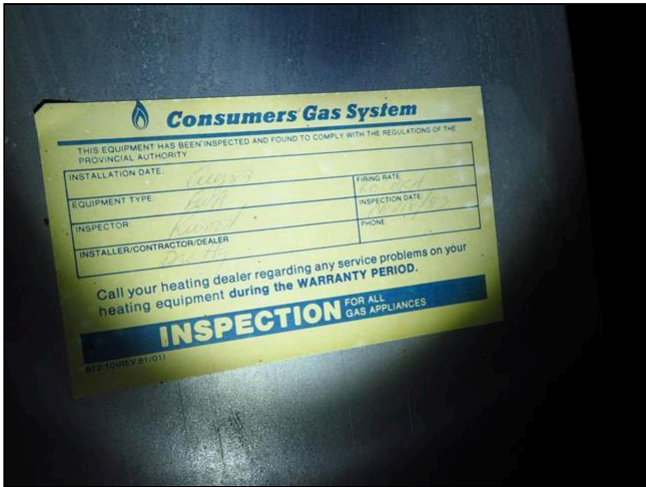
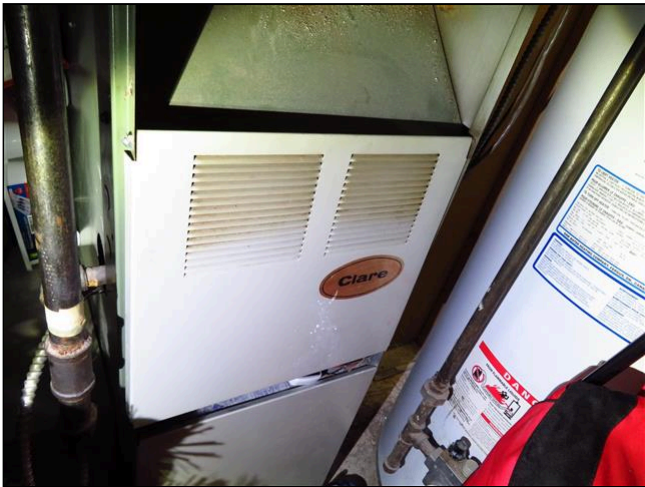
Original furnace: 1983

Plan replacement.

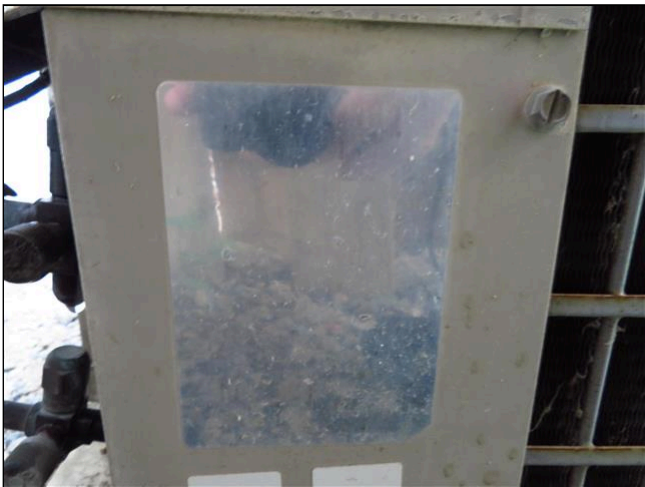
AC plate is blank.

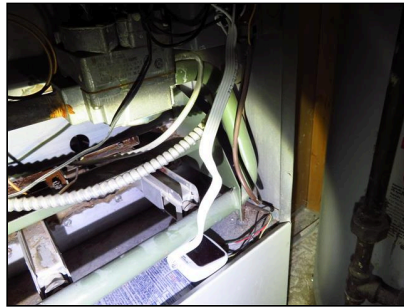
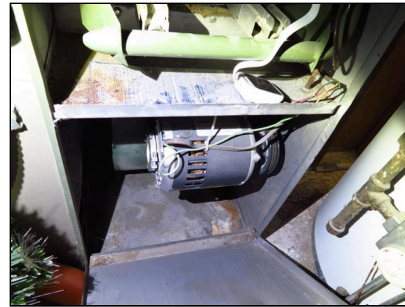
6.0 The furnace is very old but did work at time of inspection. I am unable to determine life remaining. However, strongly recommend replacement rather than inspection and service. Consider a combination heating system where the water heater can be used to provide both plumbing and space heating requirements.

6.0 Item 1(Picture) Limited viewing of heat exchanger.

6.0 Item 2(Picture) Furnace fan.

High efficiency furnaces are an investment when upgrading to 95% from 65% standard combustion efficiency. Plan replacement in the near future.

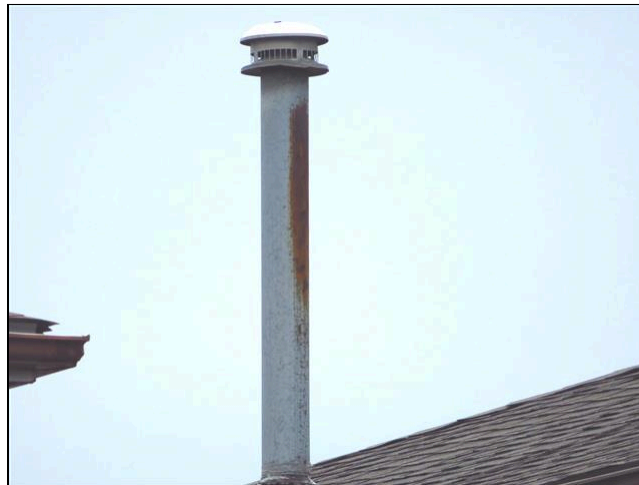
6.5 The chimney on the roof can be removed when the water heater and furnace are replaced with current high-efficiency options.

6.5 Item 1(Picture) 40-years old.

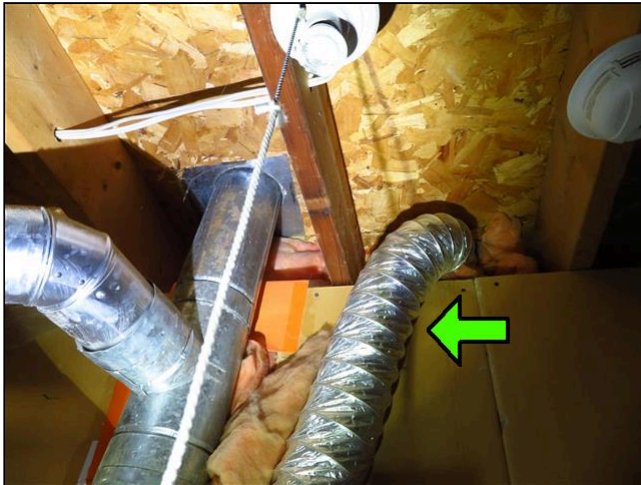
Upgrade this.

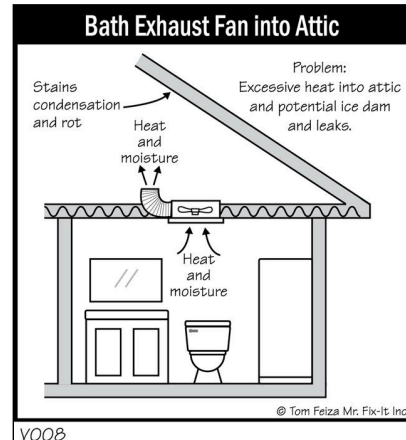
Investigate and repair.

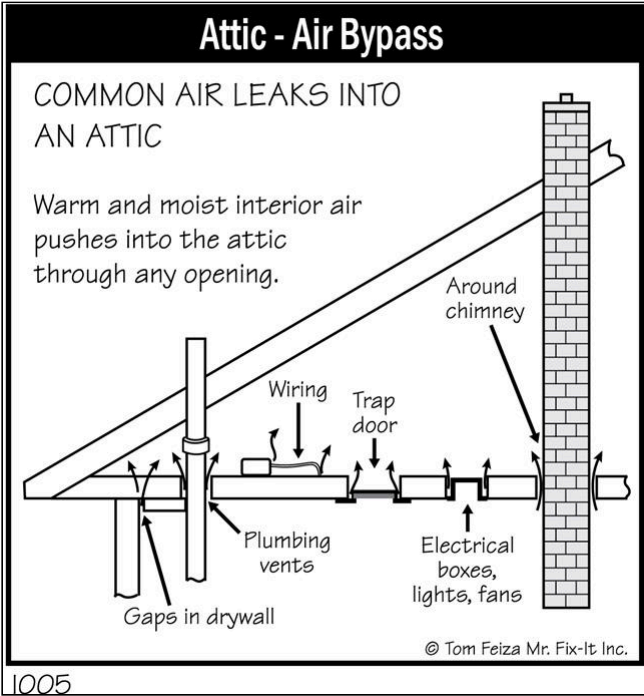
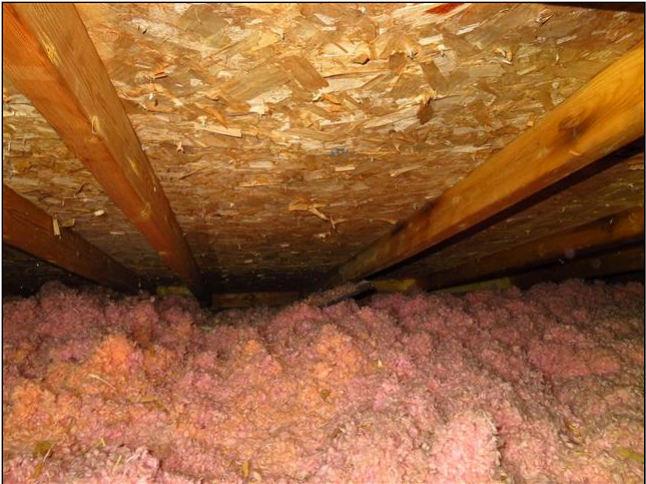
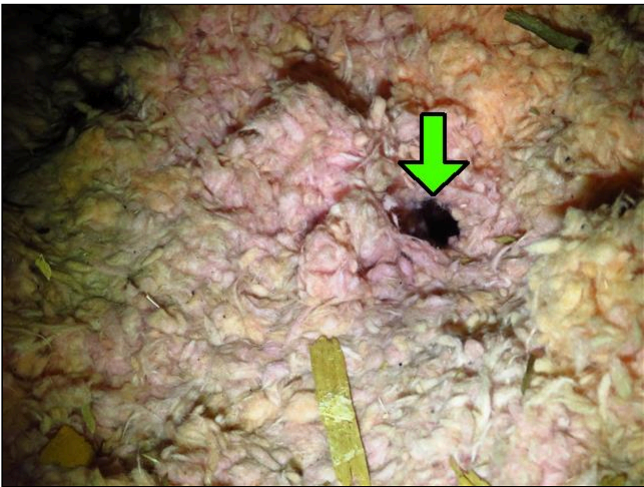
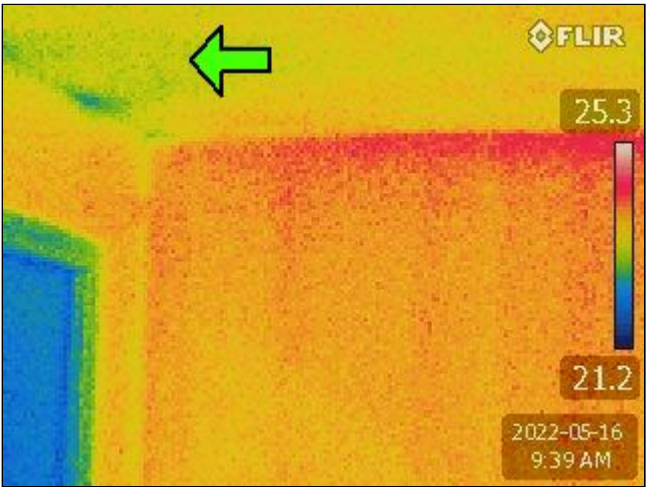
7.0 Blown insulation is only R 24 to R 28 and does not meet the R 60 currently required. Heat loss can occur more on this home than one that is better insulated. It is recommended that the attic be improved ensuring attic floor preparation and air sealing as well as maintenance of proper ventilation.

7.0 Item 1(Picture) Attic floor preparation.

7.0 Item 2(Picture) Compressed (damaged) material

7.0 Item 3(Picture) Burrowing animals.

7.0 Item 4(Picture) Damage increases heat transfer.

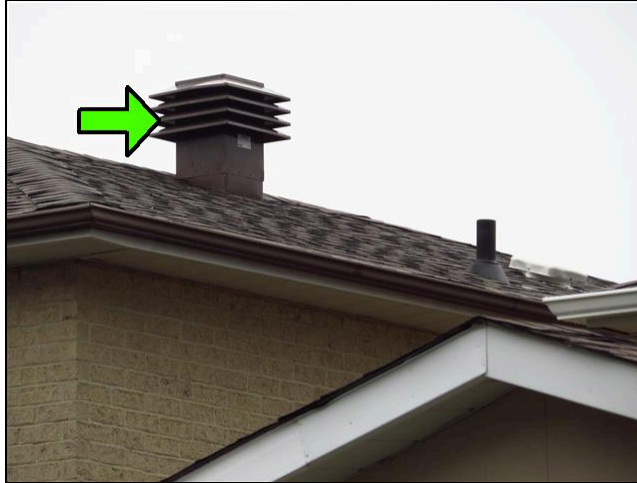
7.3 Attic ventilation has been upgraded.

7.3 Item 1(Picture) Increased air movement.

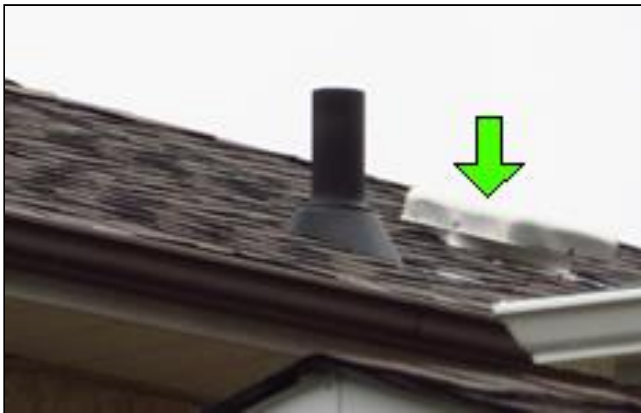
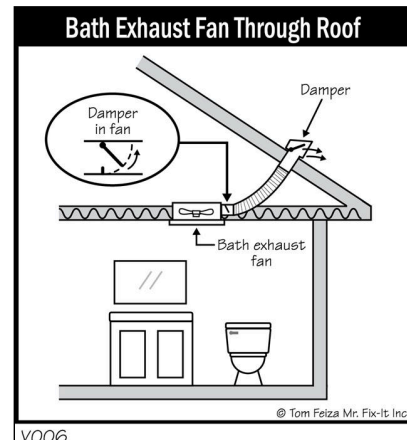
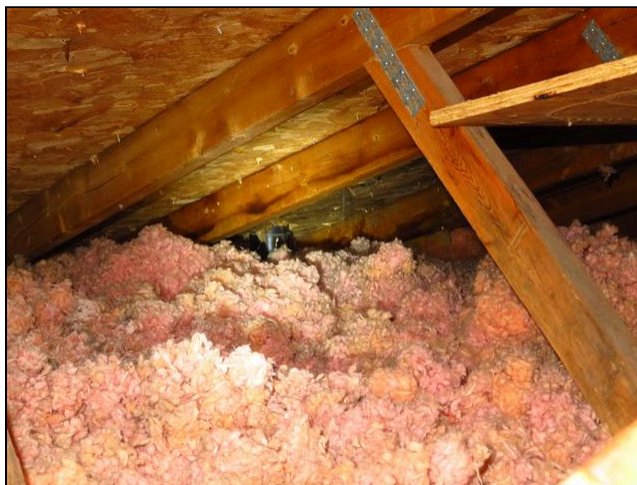
7.4 (1) From inside the attic is was not possible to see where the exhaust fans connected to the exterior dampers. The main washroom appears to have a discharge damper present. The ensuite does not.

7.4 Item 1(Picture) Possible discharge.

7.4 Item 3(Picture) Duct not visible.

This type of issue can be addressed by an attic insulation contractor when upgrading the attic. Check for programs that can provide rebates when upgrading the furnace, AC, and the attic insulation. Item 3(Picture)

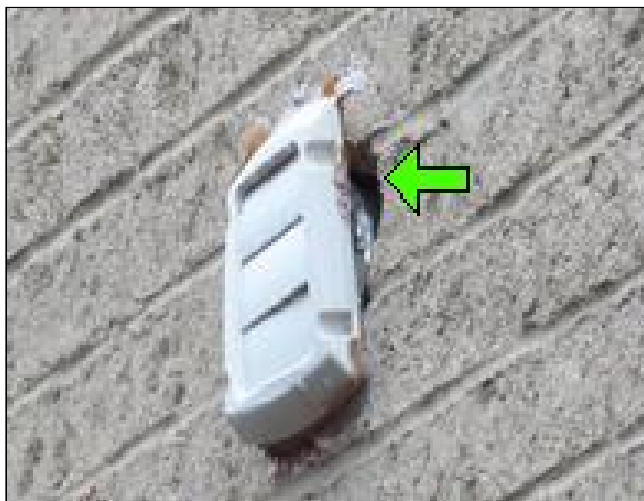
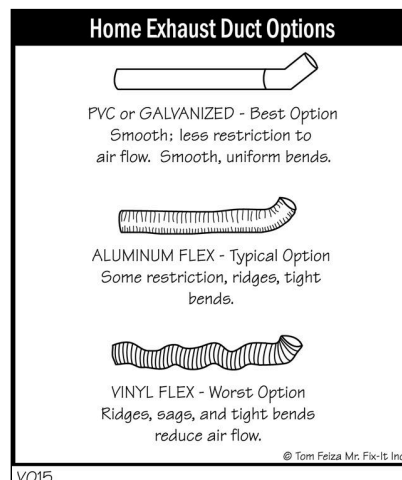
7.4 (2) There are two laundries. The basement exhaust duct is inefficient and if neglected will accumulate lint and become a fire hazard. The main floor laundry discharge could not be viewed but flexible duct is most common for this type of installation.

7.4 Item 4(Picture) If the duct is not metal upgrade it.

7.4 Item 5(Picture) Rigid and smooth is best.

Seal around the upstairs dryer vent to prevent nuisance entry. Have contractor verify that the material is straight metal and replace if necessary.

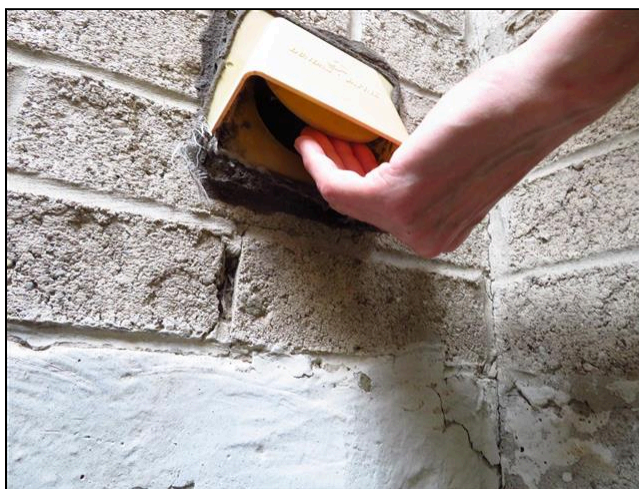
7.4 Item 6(Picture)

7.4 (3) The basement kitchen and washroom are sharing a vent discharge. Operate fans together to ensure that all waste air is eliminated.

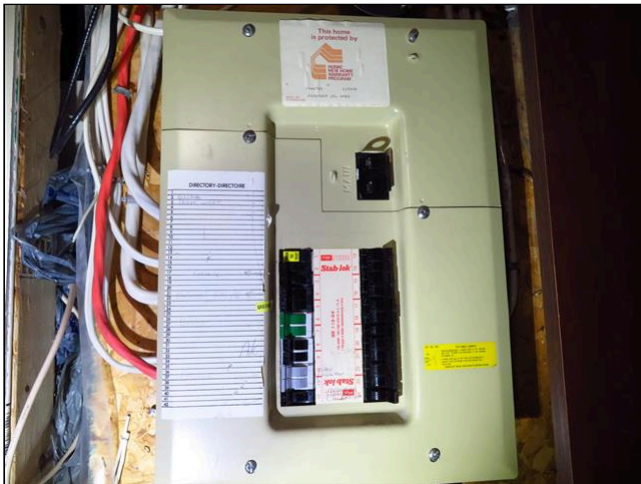
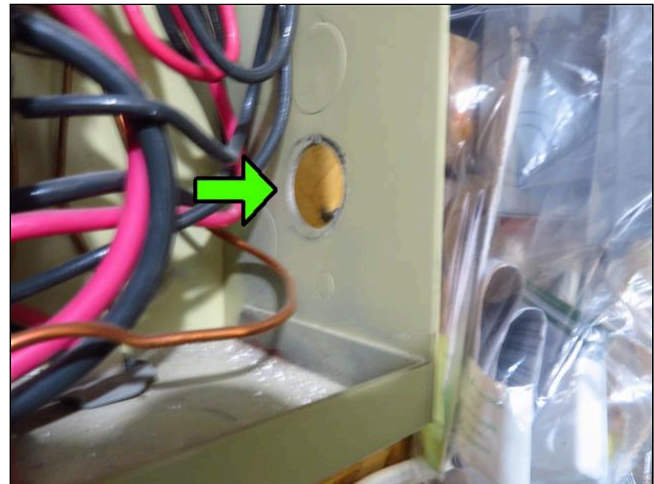
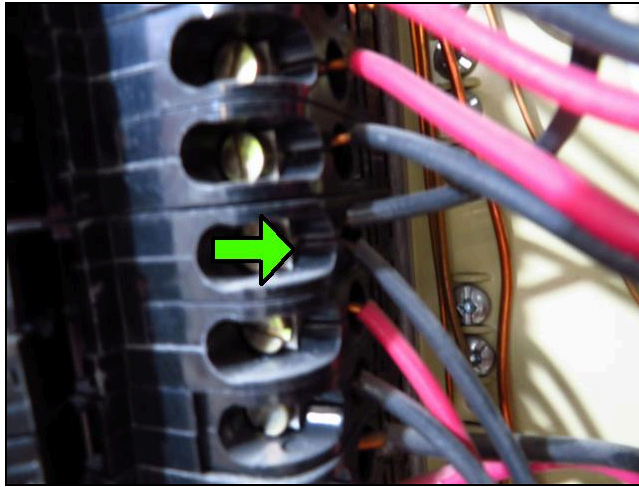
8.2 (1) This panel is a Federal Pioneer Stab-Loc panel. These have been controversial and claimed to be to be unsafe. This unit is 40-years old and has been expanded to an additional panel. There is an unsafe opening and there is one double tapped circuit.

8.2 Item 1(Picture) Poor labeling.

8.2 Item 2(Picture) Unsafe.

8.2 Item 3(Picture) Double tapped.

Get an opinion from the electrician hired to correct the issues noted below.

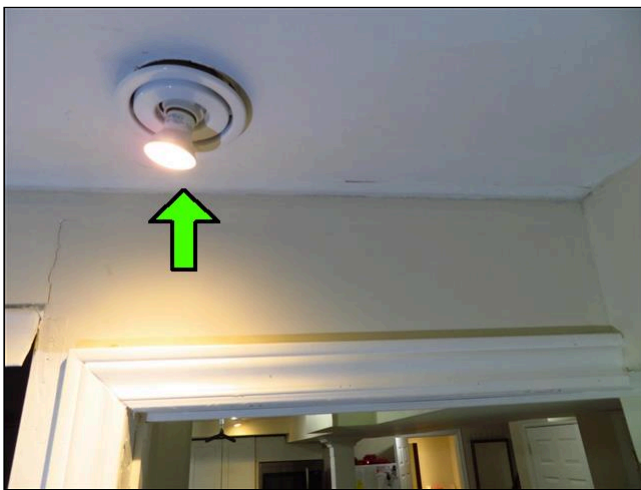
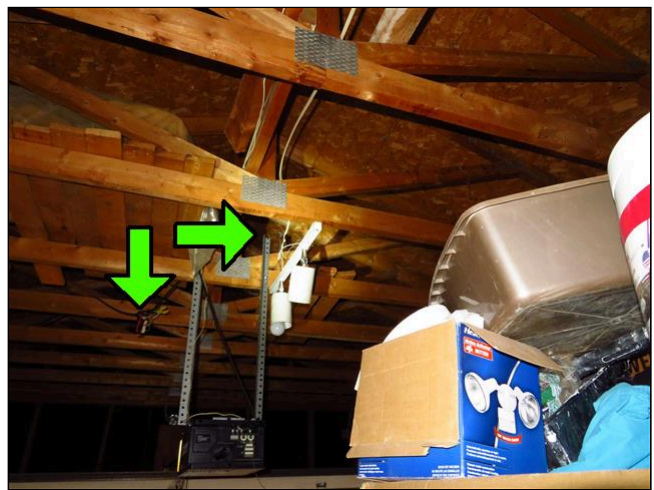
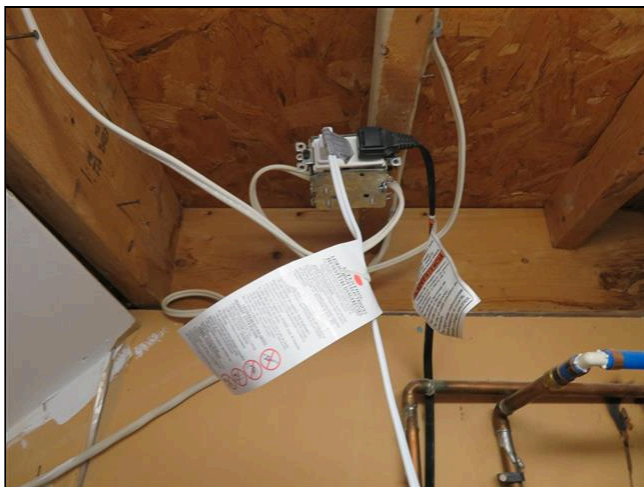
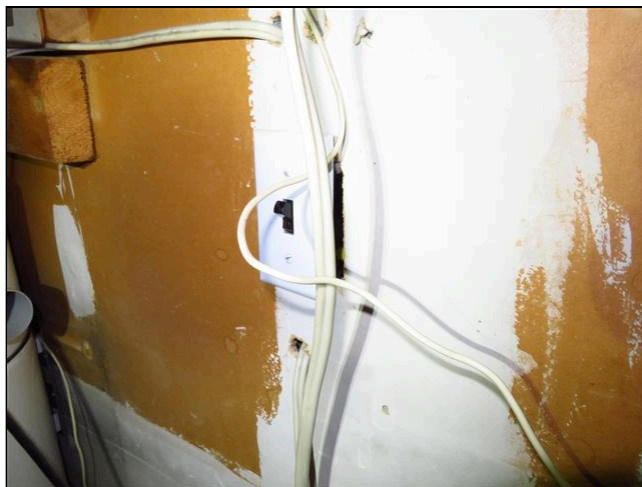
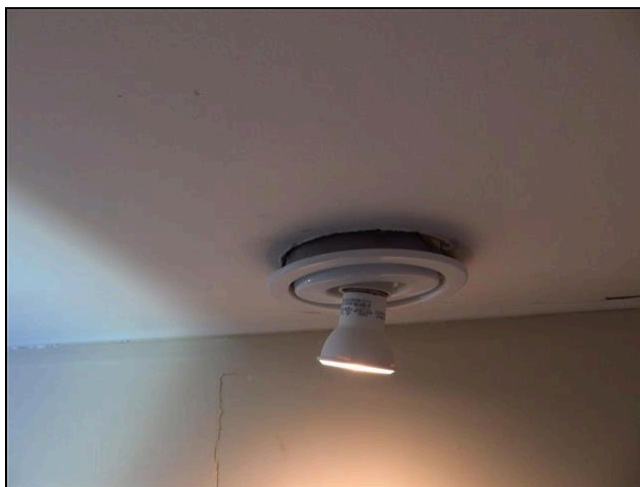
8.3 (1) There are many unsafe conditions. The electrical system must be reviewed and corrected. ESA [Electrical Safety Authority] or a tradesperson qualified by same.

8.3 Item 1(Picture) Modified fixtures.

8.3 Item 2(Picture) Open splices. Loose wires.

8.3 Item 3(Picture) Loose. Unsafe.

8.3 Item 4(Picture) Loose wiring.

8.3 Item 5(Picture) Inspection required.

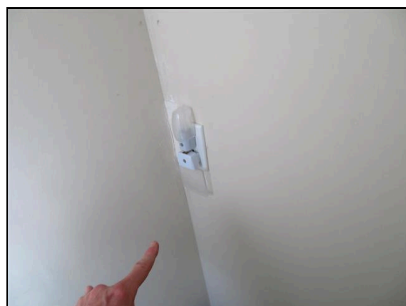
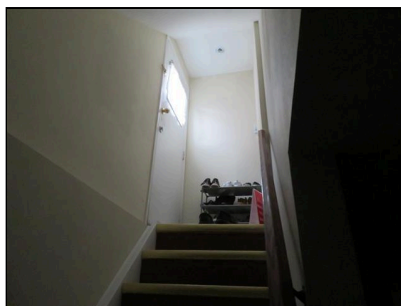
8.3 (2) There is no light switch at the top of the stairs. It would have been installed where the laundry equipment is now present. Photo-sensitive lights are plugged into the receptacle on the landing.

8.3 Item 6(Picture) Poor lighting.

8.3 Item 7(Picture) Basement stairs.

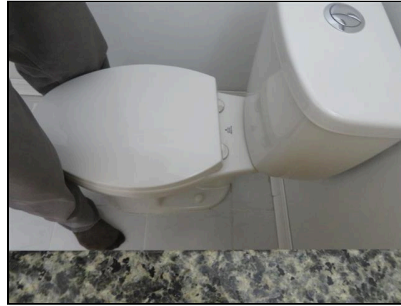
9.0 (1) The toilet is loose at floor. Repairs may involve re-setting the toilet on a new wax seal. I recommend a qualified licensed plumber repair or correct as needed.

9.0 Item 1(Picture) Fixtures must be immobile.

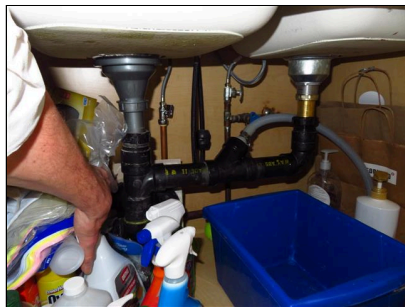
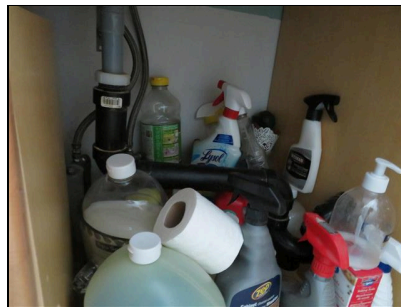
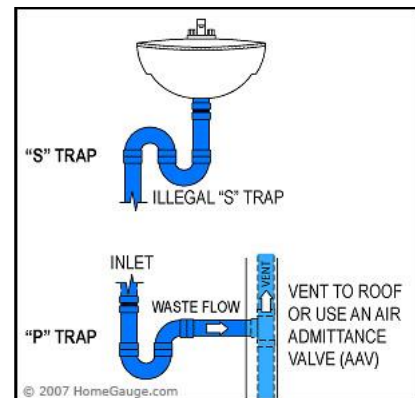
9.0 (2) Be aware that the house has s-traps as opposed to p-traps below two of the sinks. These require closer monitoring and likely more maintenance than a correctly installed fixture. Future improvements may be desirable. An "Auto admittance valve" can be used where it is difficult to reach a vent pipe.

9.0 Item 4(Picture) Common renovation solution.

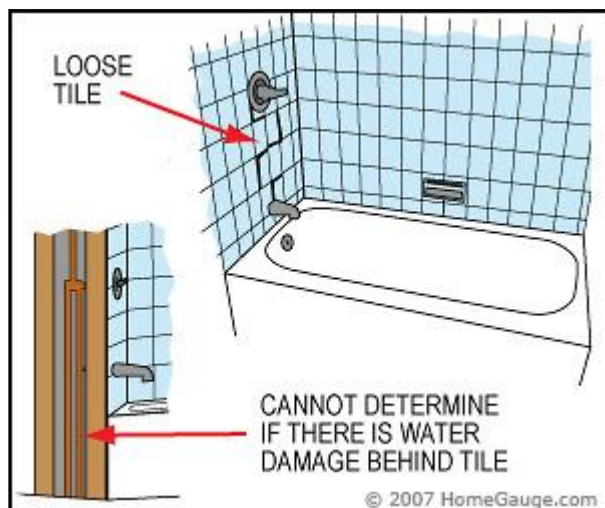
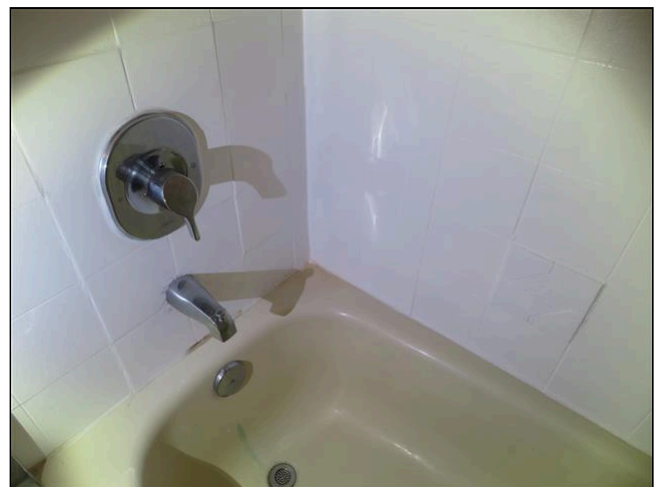
9.1 (1) Note that the upstairs tub enclosure has been repaired and painted over. This will extend the service life. There will likely be hidden damage discovered when renovation is required.

9.1 Item 1(Picture) Prior to repair.

9.1 Item 2(Picture) Main washroom.

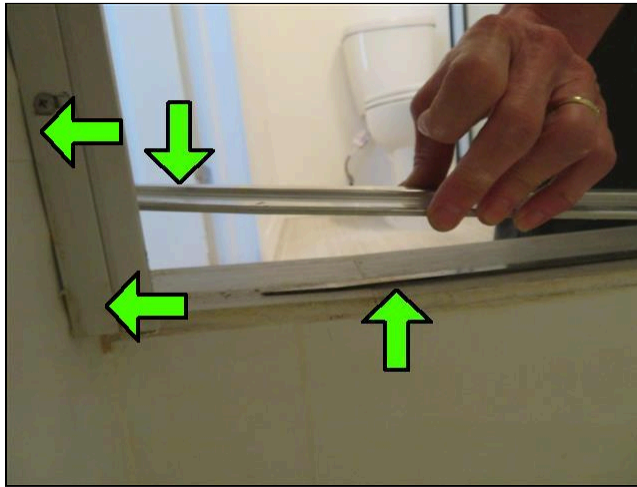
9.1 Item 3(Picture) Prevent water leakage.

9.1 (2) Secure the components and seal under the ensuite shower threshold.
